ADA TITLE II SELF-EVALUATION & TRANSITION PLAN

JANUARY 2015

**City of Grass Valley
Public Works Department
125 East Main Street
Grass Valley, CA 95945**

A Collaborative Effort of Disability Access Consultants (DAC) and the City of Grass Valley

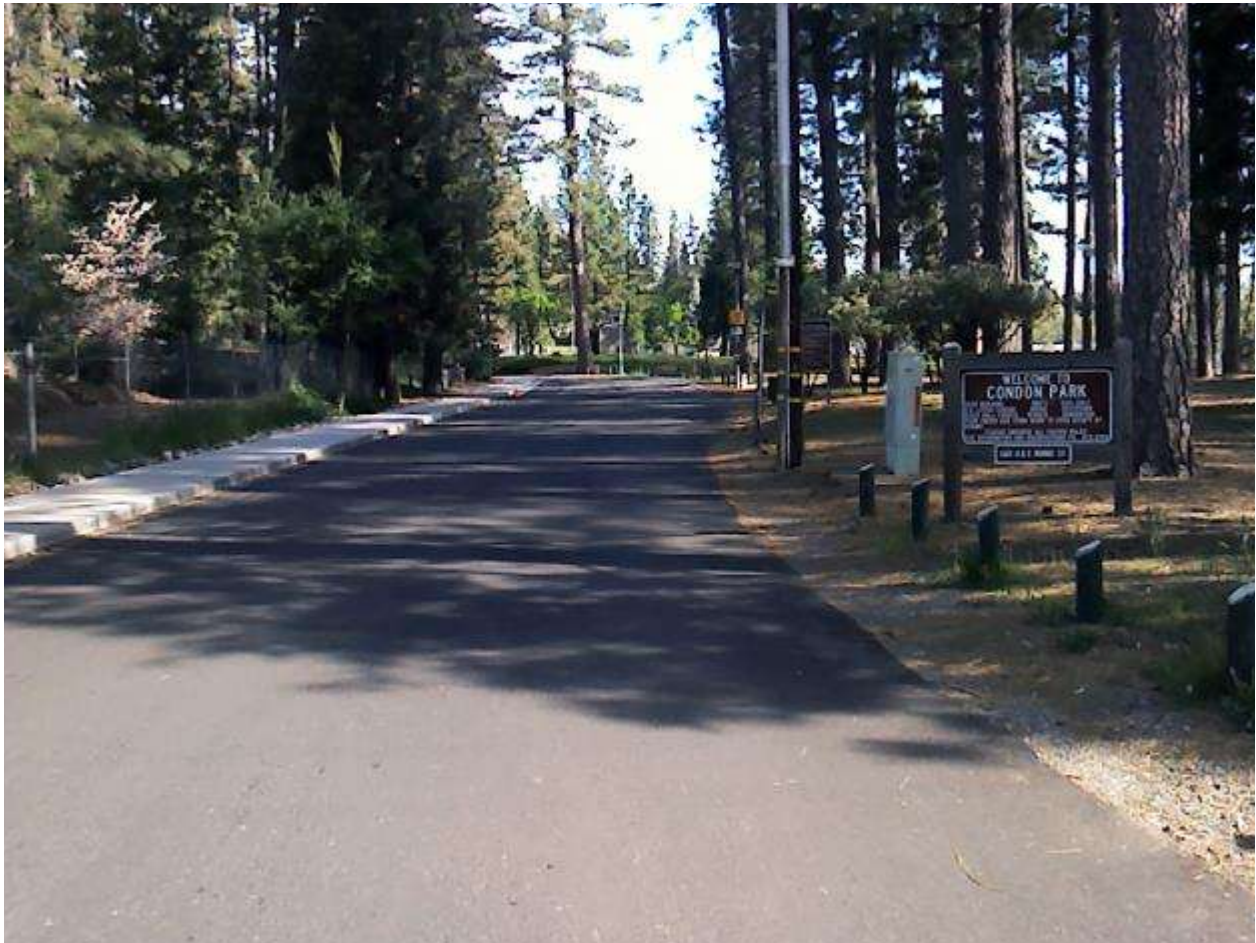
City of Grass Valley Condon Park

Accessibility Survey

660 Minnie Street
Grass Valley, CA 95945

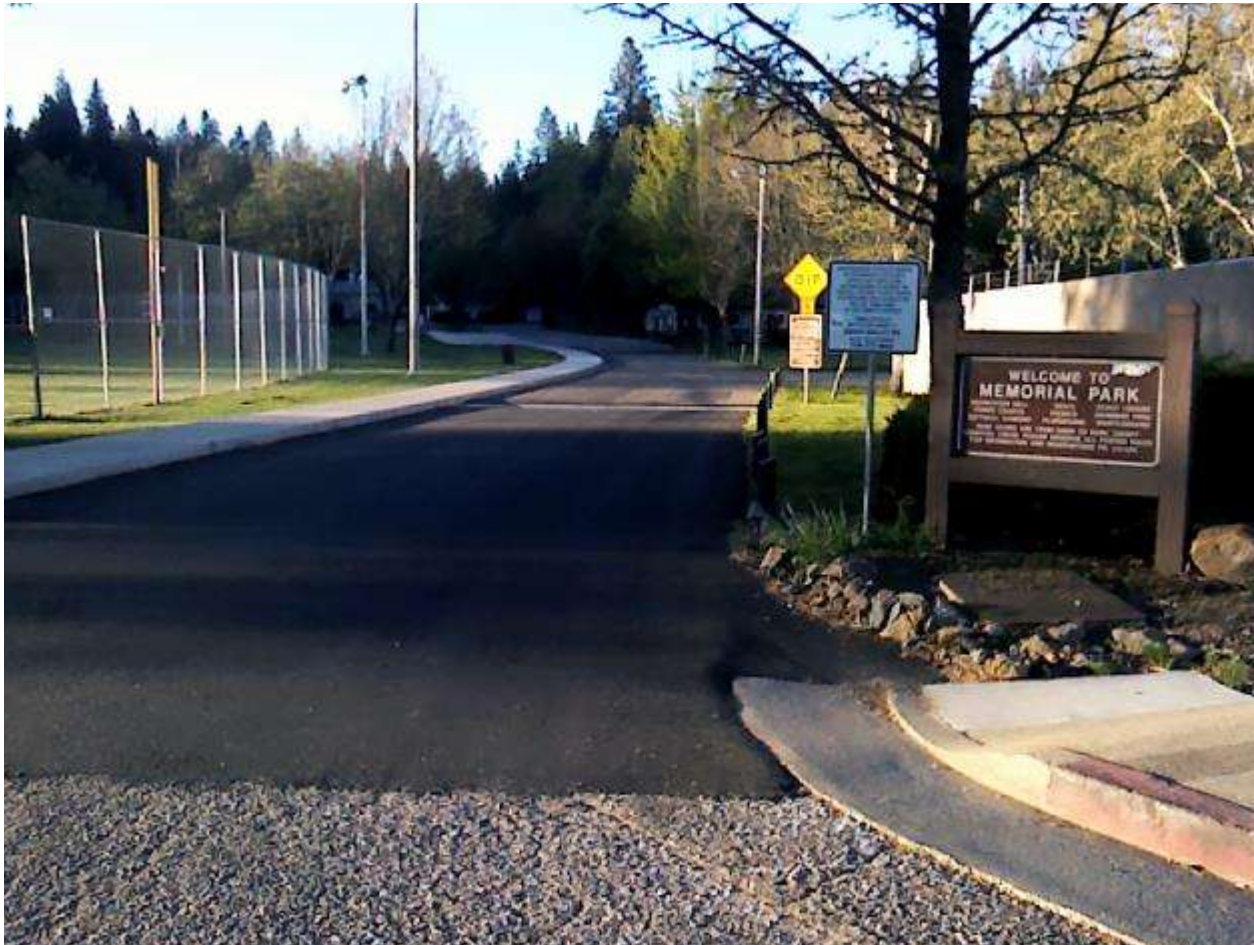
City of Grass Valley Memorial Park

Accessibility Survey

415 Central Avenue
Grass Valley, CA 95945

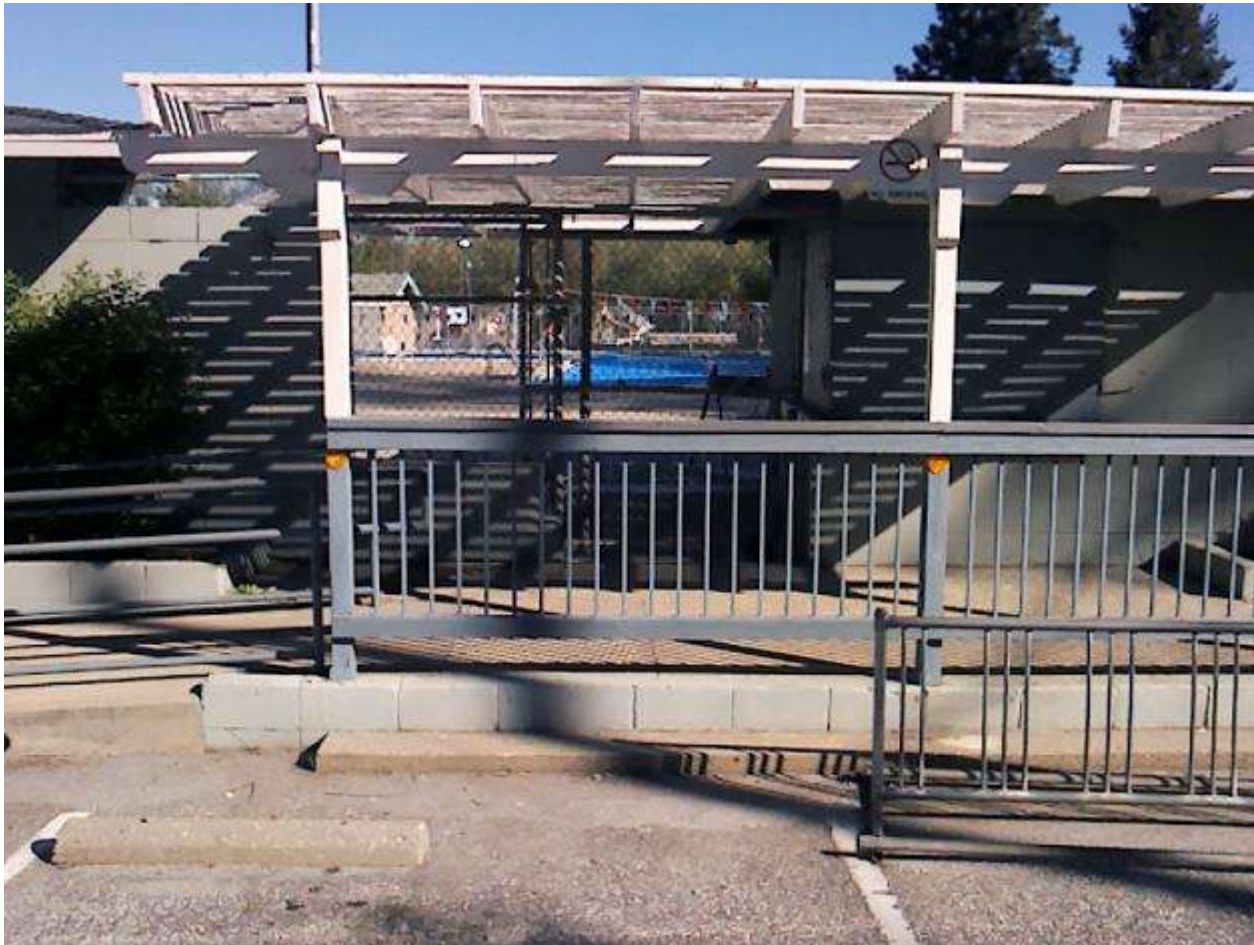
City of Grass Valley Municipal Pool

Accessibility Survey

415 Central Avenue
Grass Valley, CA 95945

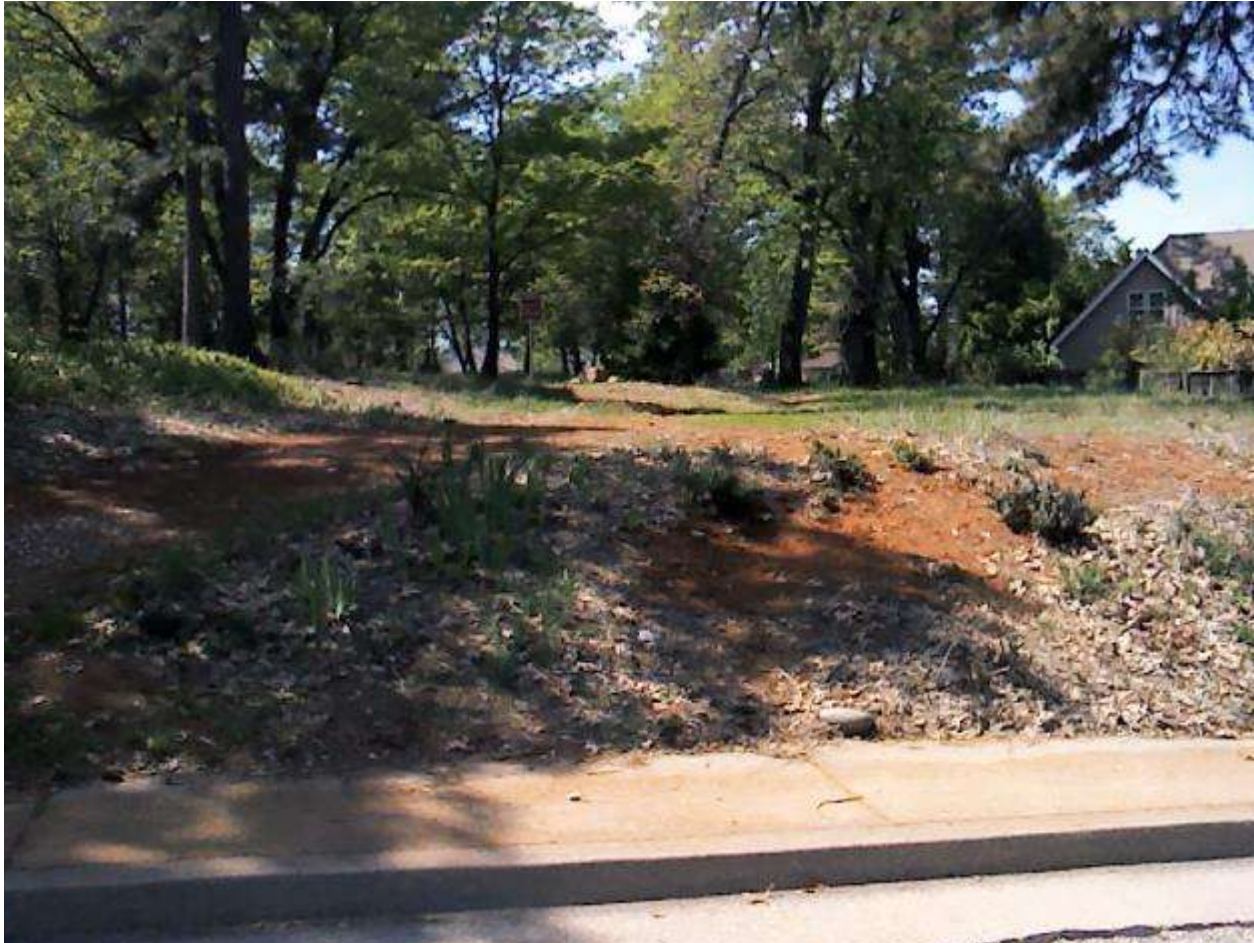
City of Grass Valley Ventana Sierra Open Space

Accessibility Survey

164 Ventana Sierra Drive
Grass Valley, CA 95945
